# Inspecting Laser Micro-machined Si Tips for Current Injection into Liquid Xenon

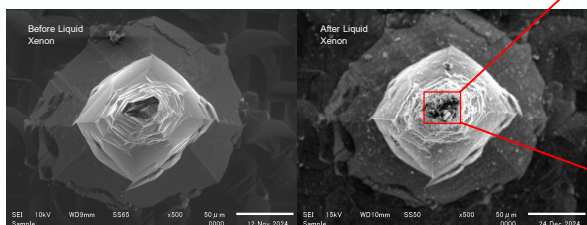
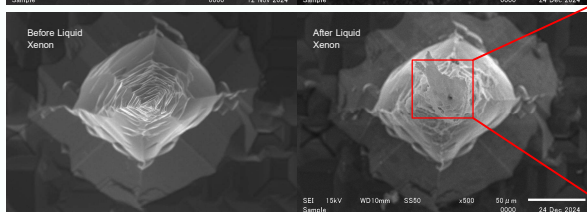
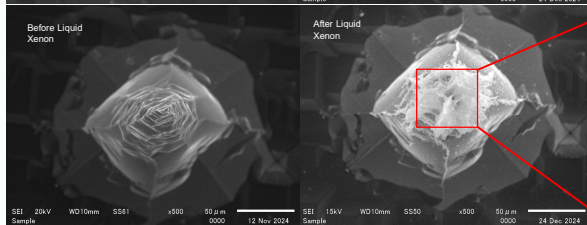
## SEM Pictures

- Edge damage
- Coating loss (Copper coating blown off from the surface)
- Fuzzy material deposition
- Tip outgrowth

- Brownish material of unknown composition was found: Amorphous Silicon?
- Outgrowing structure was formed.
- Need to reduce the deformation of tips, potentially by trying a different material of the tip such as **copper**.
- Examine and improve our setup: **coating is not necessary**
- Need to repair the **Energy dispersive X-ray spectroscopy (EDS)** that is attached to the SEM to study elemental composition.
